Manhole Inspection Summary

Manhole # S37GG_027MH

Location Address: **422 OLIVER ST**

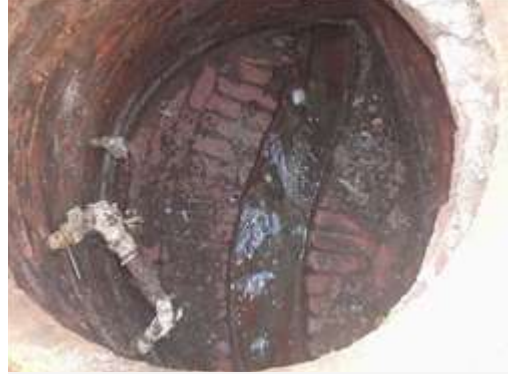
Top View

Evidence of surcharge - Bench debris.
Corroded steps.

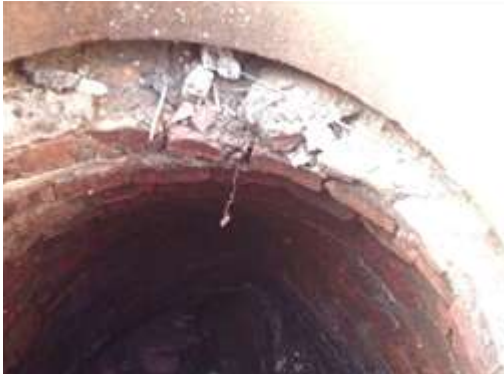
Defect

Frame leaks. Frame offset. Adjustment deterioration, loose brick and infiltration. Corbel infiltration.

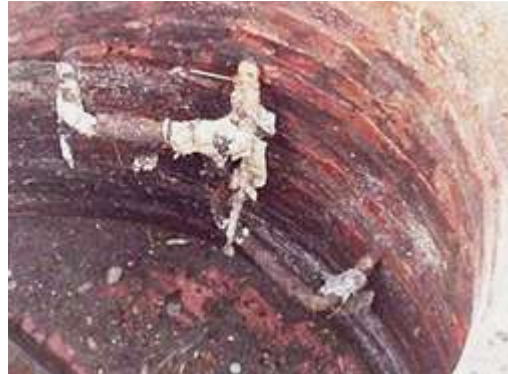
Defect

Evidence of surcharge. Barrel infiltration.

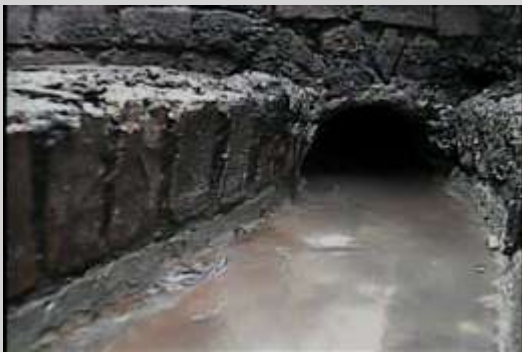
8 in. Circular Gravity Sewer Pipe Out @ 12 O'Clock

Barrel deterioration and infiltration. Channel deterioration.

Deposits: ☐ None ☒ **Mud** ☐ Sludge ☒ **Debris** ☒ **Grease**

Silt Depth: **0.5** (in.) Deposits Extent: **Light**

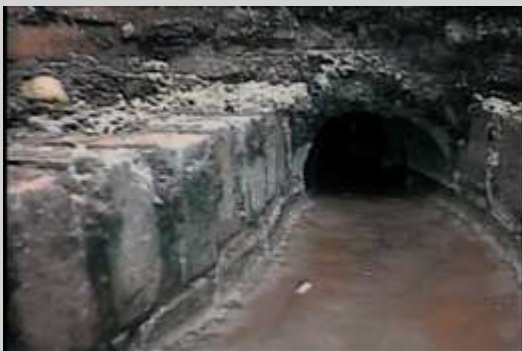
8 in. Circular Gravity Sewer Pipe In @ 6 O'Clock

Barrel deterioration and infiltration. Channel and Bench deterioration.

Deposits: ☐ None ☒ **Mud** ☐ Sludge ☒ **Debris** ☒ **Grease**

Silt Depth: **0.5** (in.) Deposits Extent: **Light**
